Assessment and restoration of water bodies at four sites maintained by the Archaeological Survey of India

Technical Report prepared by

IPCA Centre for Waste Management and Research

An Industry-Academia technical collaboration under the CSR activities of Bisleri International Pvt. Ltd. for rejuvenation of water bodies at ASI sites

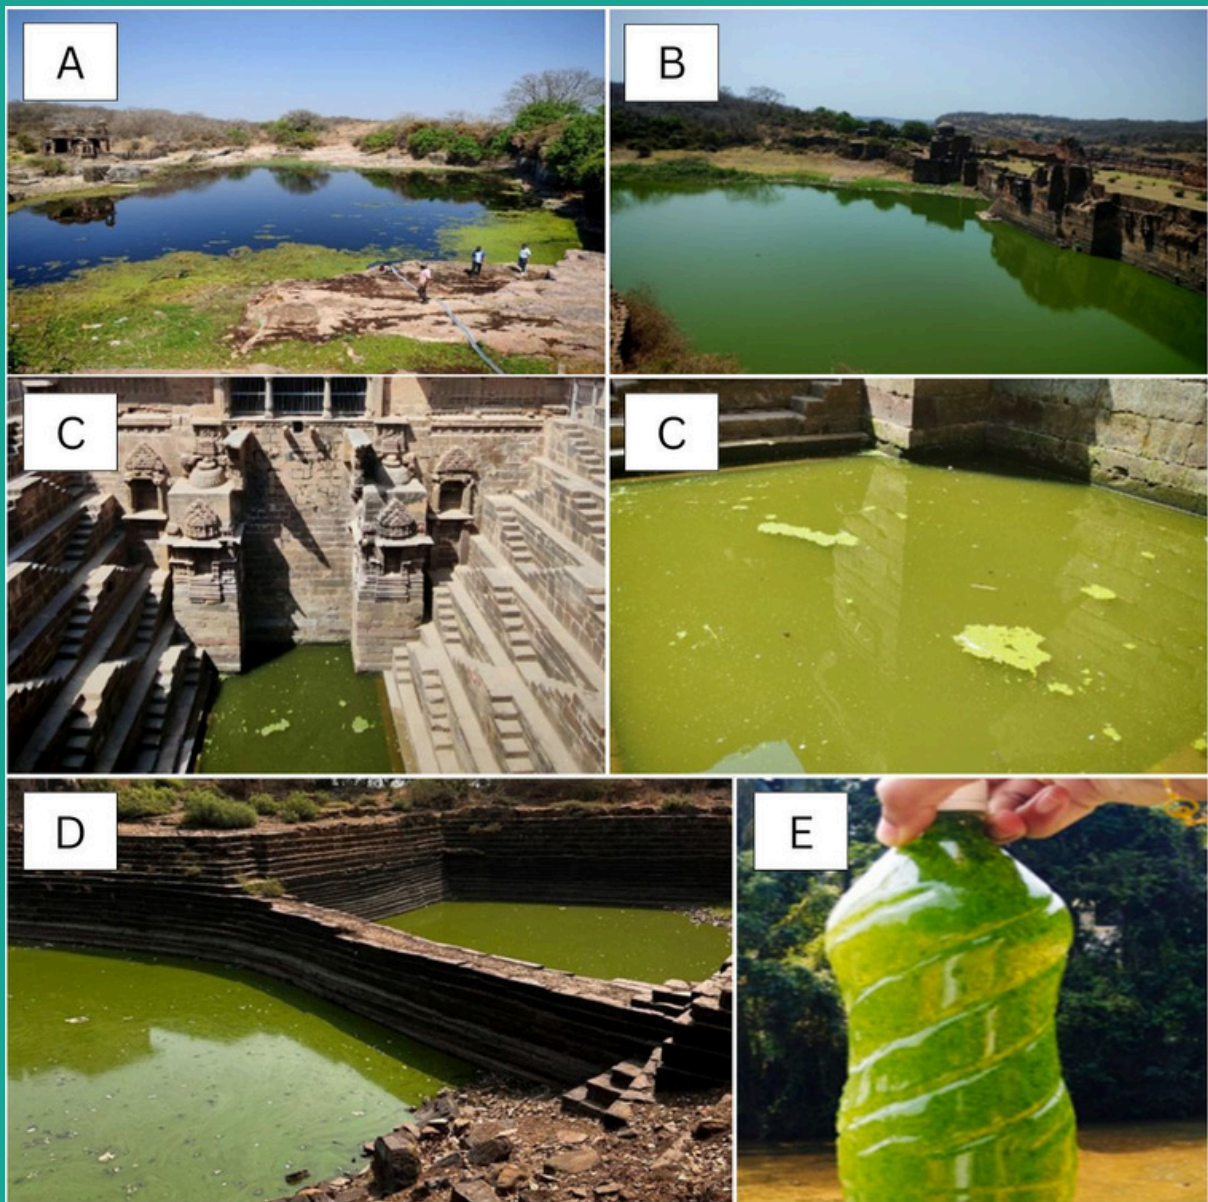
Figure 2.1 illustrates the water condition as of May-June 2025. The water appears green due to algae. The physical appearance of the ponds indicates that Buddha Buddhi Talab is the worst affected, followed by Chand Baori, Rani Talab, and finally, Padmavati Talab. The

Figure 2.1 Images of (A) Rani Talab (Ranthambore); (B) Padmavati Talab (Ranthambore); (C) Chand Baori; (D) Buddha Buddhi Talab; (E) Sample collection in the bottle.

water in these ponds remains stagnant for most of the year because there is no outlet, and they are primarily fed by rainwater runoff from the surrounding areas. These conditions are favourable for nutrient accumulation in the ponds, promoting algal growth.

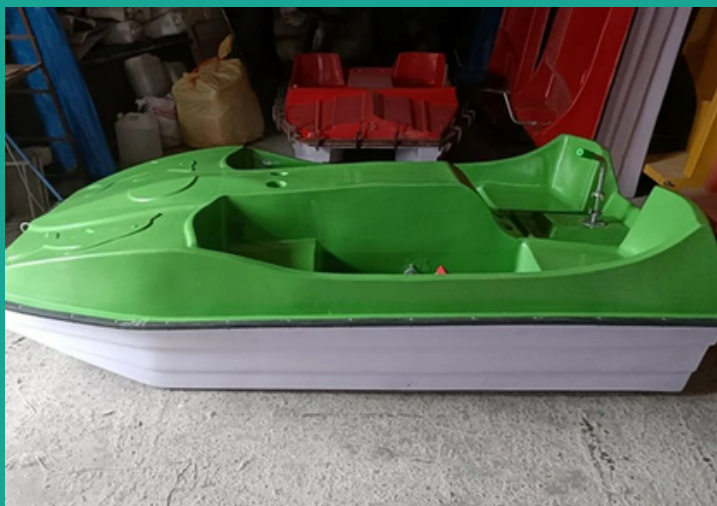
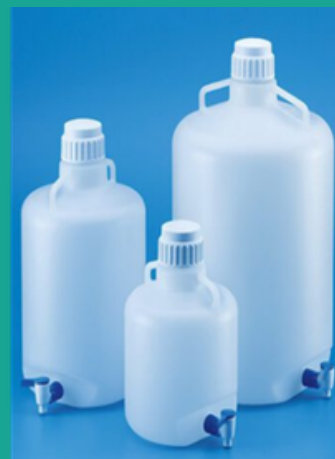
Figure 2.5 An example of the paddle boat and aspirator bottle

We recommend using a paddle boat that can accommodate two people for propulsion. Additionally, the back of the boat should hold two 25-litre aspirator bottles containing the HI solution. An example of this paddle boat and the aspirator bottle is shown in Figure 2.5. Additionally, a 2000-litre capacity Syntax tank will be located near the pond to prepare the stock solution of HI. For small water bodies, such as Chand Baori and Buddhi Talab, we recommend using handheld sprayers, as shown in Figure 2.6. Images of commercially available hydrogen peroxide and iodine solution are given in Figure 2.7.

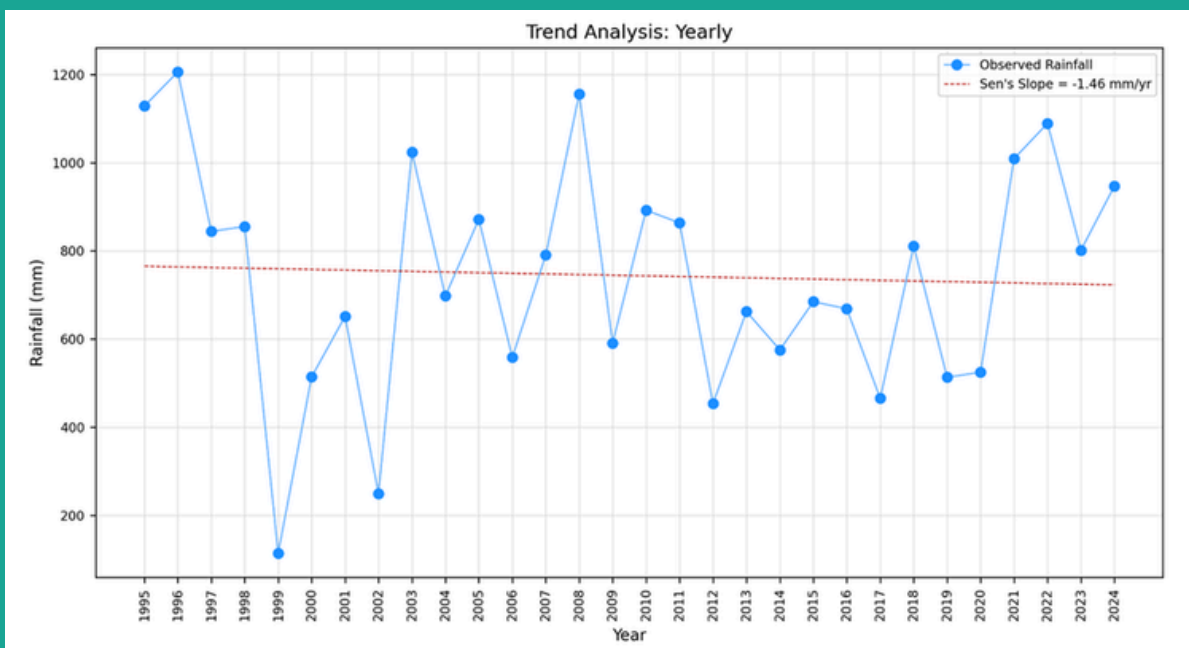
Figure 3.2 Rainfall trend analysis at Neemrana Baori (Sen's slope is -1.46 mm/year)

Even though Neemrana Baori receives an annual average rainfall of 720 mm, it has been observed that the stepwell is located on the rain shadow or leeward side of the Aravalli, thus receiving far less rainfall than the district average of 720 mm. Mann-Kendall rainfall trend analysis (Figures 3.1 and 3.2) indicates that Chand Baori exhibits an increasing rainfall trend, whereas Neemrana Baori displays a declining trend.

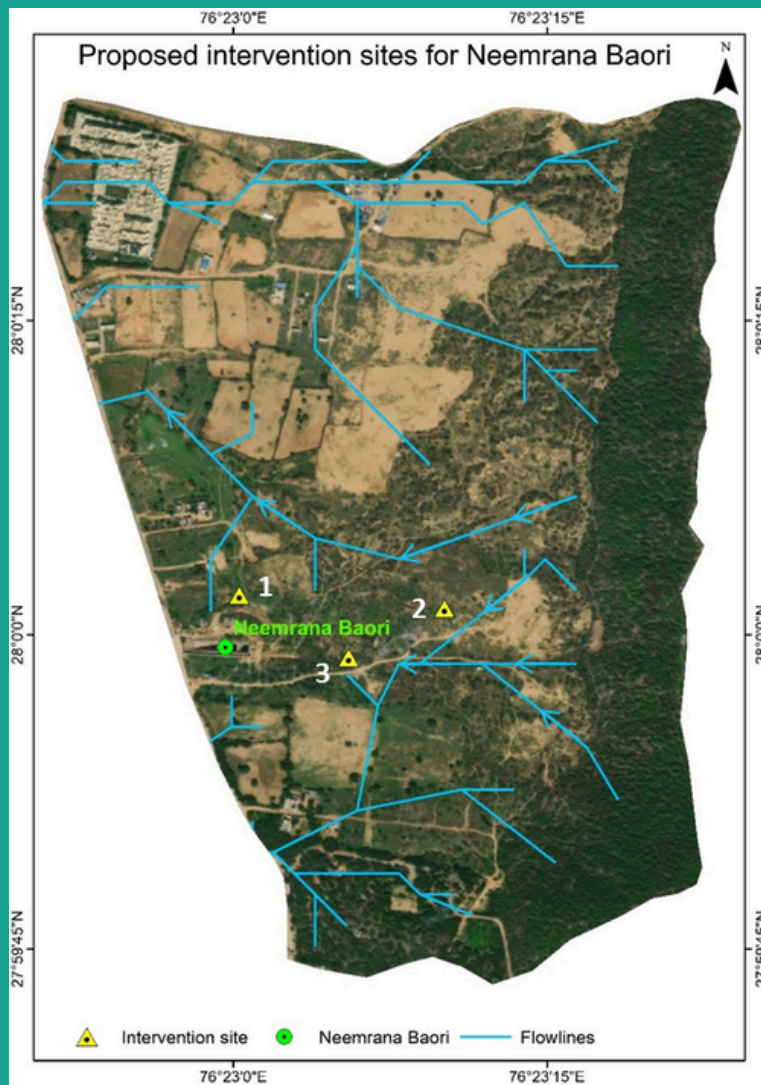
Figure 3.8 Location of the recharge structures (1, 2, and 3) at Neemrana Baori

We propose two groundwater recharge structures at Chand Baori and three at Neemrana Baori. Figures 3.7 and 3.8 show the locations of the recharge structures, and Table 3.3 provides the precise locations of these structures. Figure 3.9 gives the civil work details of the recharge structure.

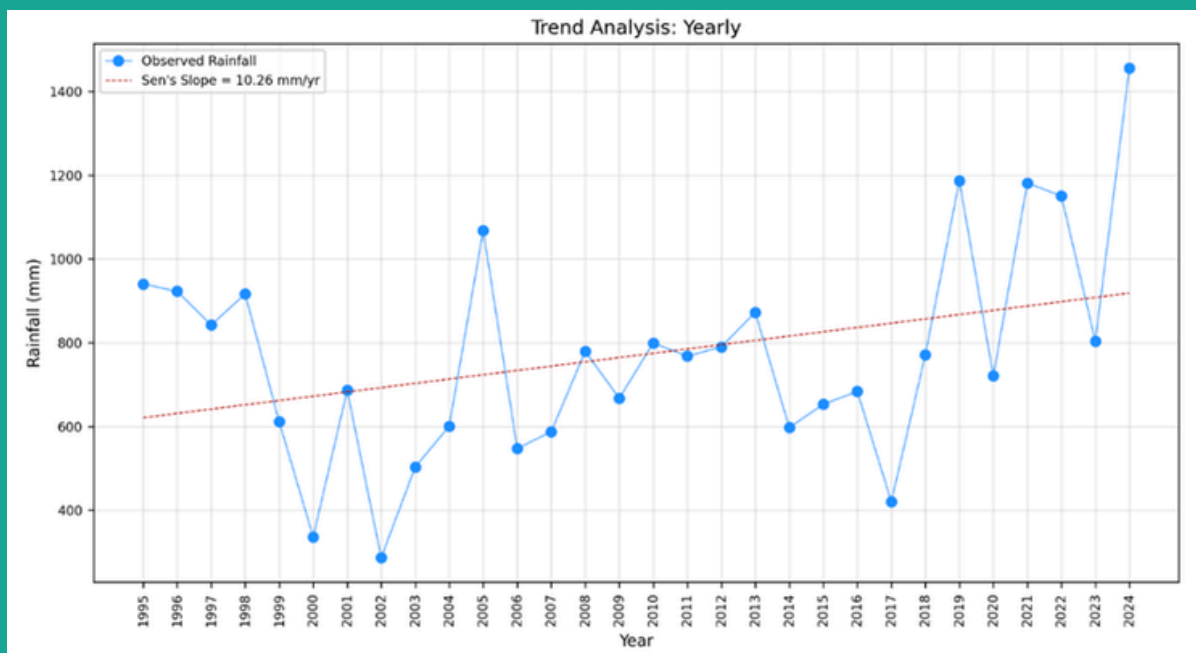
Figure d Trend analysis for yearly rainfall at Ranthambore

In terms of rainfall, the Sawai Madhopur district, which receives high annual precipitation averaging 771 mm (predominantly between 700 and 800 mm), ensures adequate runoff to keep the water bodies perennial, with rare drought years (see Figure d). Additionally, the hard rock geology below prevents water seepage.
